## SCAFFOLDS AND WORK PLATFORM SAFETY

Issue 54 Volume 1 JULY, 2019

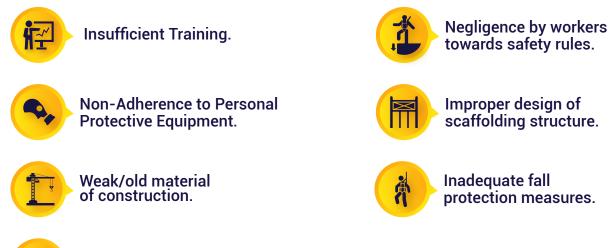
# **CAUSE OF SCAFFOLDING ACCIDENTS**

Changing environmental conditions. (extreme temperates, high winds, presence of corrosive environment)

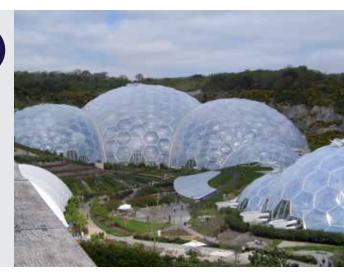
# WORLD'S LARGEST SCAFFOLDING PROJECT

The Eden Project at Cornwall, UK consists of two biomes spanning 16,000 and 7,000 square meter respectively. The height of these biomes are 55 and 35 meters. While constructing it in year 1998, 370 km long scaffolding was used. It is mentioned in the Guinness World Records.
